SURFACE OIL DISPLACEMENTS BY
U. S. COAST GUARD 82-FOOT CUTTERS

FINAL REPORT

U.S. DEPARTMENT OF TRANSPORTATION
UNITED STATES COAST GUARD
RESEARCH AND DEVELOPMENT

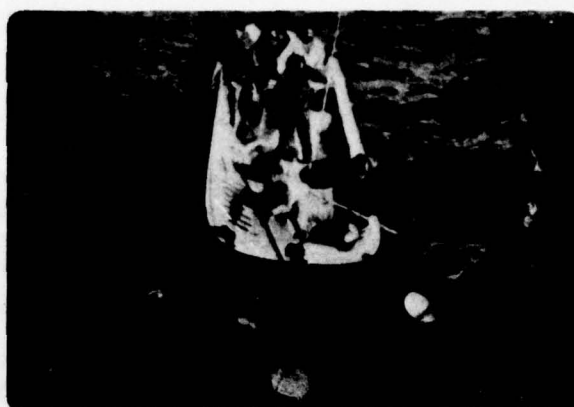
FIG. 3. Oil Sampling in Progress

consisting of a circular aluminum frame, approximately 15½ inches in diameter, which houses a 3-M Inc. Type 156 oil sorbent pad (Figure 2). The pad is stretched across the frame prior to sampling operations and spring locked shut for quick release. The sampler is attached to an eight foot wooden pole using a chain bridle. Oil samples are obtained by lowering the "cookie cutter" into a slick for five to ten seconds. In principal, any oil present in the surface area cut by the sampler should adhere to the water repellent sorbent pad during the relatively short contact period. An aluminum lid, loosely fitted to the top of the sampler prevents spillover during sampling and insures that oil "captured" on the sorbent pad is from the "cut" area only. Following the dipping operation, the sorbent pad is removed from the aluminum frame and placed in a 32 oz. glass storage jar for analysis. Removal of a stained pad and its replacement with a clean pad takes from 45-60 seconds. From 30-45 surface samples were acquired during each test day using the "cookie cutters." A 21-foot Boston Whaler operated by UCSB's Marine Science Insititute (MSI) was used as a sampling platform (Figure 3).

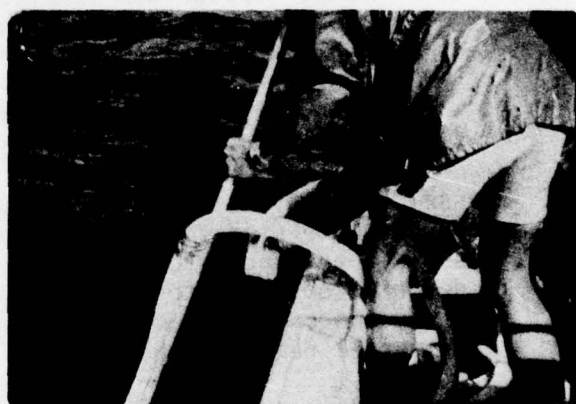
FIG. 5. Subsurface Sampling Operations

UCSB Boston Whalers were used as sampling platforms on both dates. The sampling apparatus consisted of a hand-operated Gusher 10 pump, 25 feet of 1½ inch diameter flexible plastic hose, and an 18 foot long aluminum pole. The plastic hose was secured to the aluminum pole and connected to the pump. Subsurface samples were obtained by lowering the aluminum pole/hose combination to the desired sampling depth then drawing water up through the hose for capture in 32 oz. storage jars (Figure 5). A total of 36 subsurface samples were collected on December 8. A further 33 samples were acquired December 15 using this method.

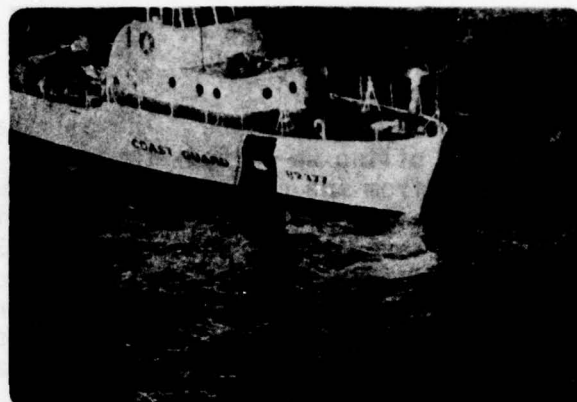
FIG. 11. PT. HOBART Proceeding with
Swell (Transect 2, 12/15/77)

Effects of ocean/weather conditions on ship operations: Pitch and roll were slightly reduced during the transect. Swell waves passed along the hull as in Transect 1 but the bottom of the hull was not exposed (Figure 11) and no "splash out" of water was observed.

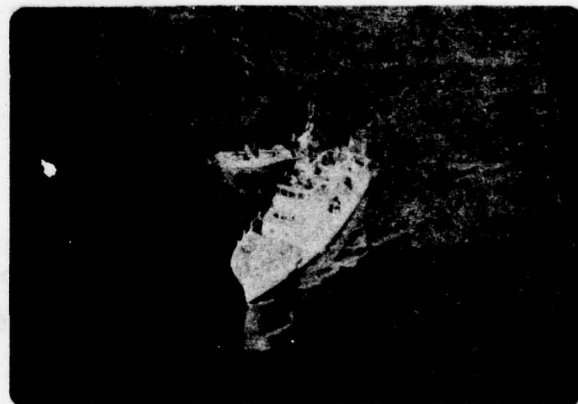
FIG. 13. Breaking Bow Waves in Thin-
ner Oil (Transect 2, 2/21/78)

During this transect, bow and stern waves formed as ship speed reached four knots. At times, the primary bow wave, first and second divergent bow waves, and stern wave were observed breaking. This run provided good evidence of the wave dampening effects of oil. Where there was thick emulsified oil, surface tension tended to dampen the breaking bow and stern waves (Figure 12). When the cutter passed through thick oil into areas of thinner oil, the dampening effect was reduced and the vessel-induced waves began to break and show whitewater (Figure 13).

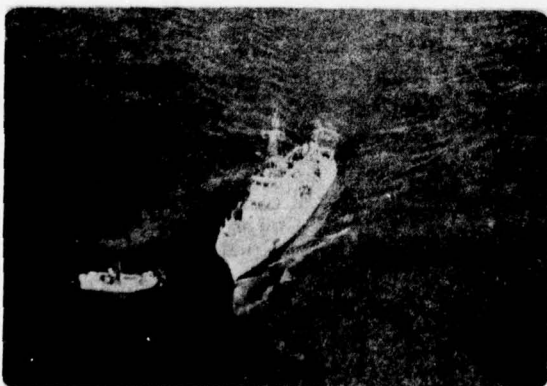
FIG. 18. Oil Sliding into Stern Wake
(Transect 3, 2/21/78)

When the oil reached the stern area, it was affected by turbulence from the stern wave and small eddies forming adjacent to the hull and parallel to the propellers. Again, there was little clearing of oil away from the hull, with most of the oil either being piled up at the wake turbulence/undisturbed oil interface or pulled under and into the wake area. However, some oil also was observed on the surface sliding behind the stern and into the wake where it remained intact (Figure 18). This latter process appeared to be a random one, depending on vessel speed (five or six knots), status of the propeller (engaged or disengaged), thickness of oil, and general boat oscillations. Average oil thickness in the wake two minutes after the cutter passed was 0.139mm (0.005 in.) compared with 0.153mm (0.006 in.) for the same area just prior to the PT. JUDITH's pass (Table 3, Stations A and C).

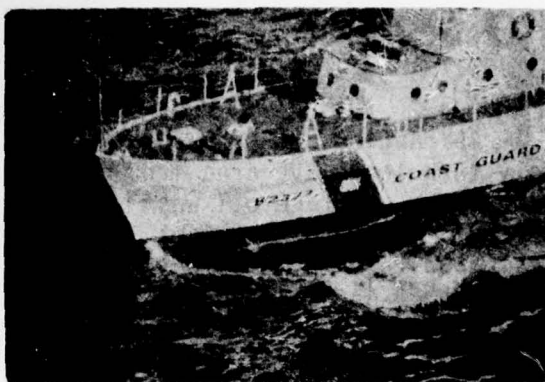
FIG. 19. PT. HOBART Creating "Splash Out" (Transect 3, 12/15/77)

Surface oil accumulations alongside the hull were broken substantially by the large "splash out" type bow waves (Figure 19). Oil was pushed out and considerable mixing and submergence occurred under these oceanographic conditions. Quantities of oil were seen in the turbulent water produced by breaking bow waves, with lesser amounts visible sliding down the backs of these waves.

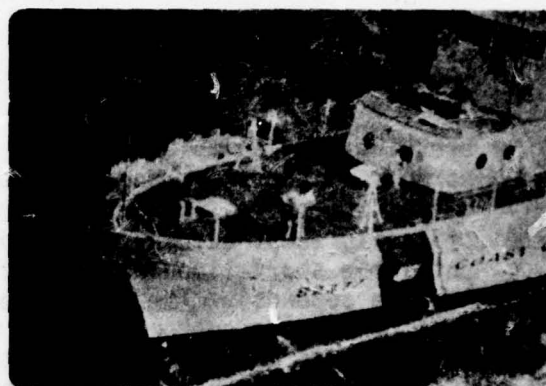
FIG. 20. PT. HOBART Lifting Out of Water During Run into Swell (Transect 3, 12/15/77)

Effects of ocean/weather conditions on ship operations: At this heading and speed, the cutter hull was observed lifting out of the water, crashing into the swell waves, and splashing out water in large amounts (Figure 20). The occurrence of these "splash out" waves was dependent upon swell size, frequency, and direction and hull angle.

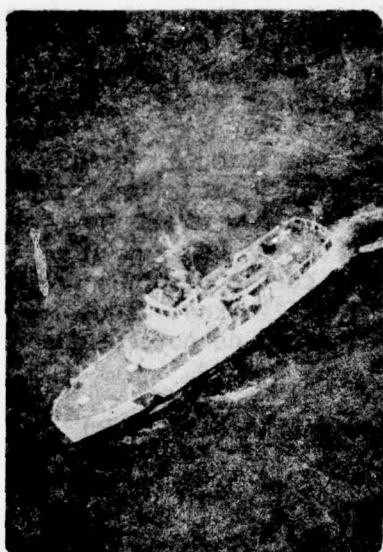
FIG. 21. PT. EVANS Underway at 6-Knots Showing Well Developed Bow Waves (Transect 1, 12/8/77)

Throughout the run, the PT. EVANS created well defined primary and divergent bow and stern waves (Figure 21). These were attributed to the cutter speed. When the bow waves were breaking, undisturbed surface oil on the wave crests was observed being churned under or pushed out away from the cutter. This was especially apparent in the whitewater areas created by the divergent (secondary) bow waves and the resulting zone of turbulence created between the ship and the wave crest (Figure 22). Oil displacement was very regular both to starboard and port of this heading into the swell.

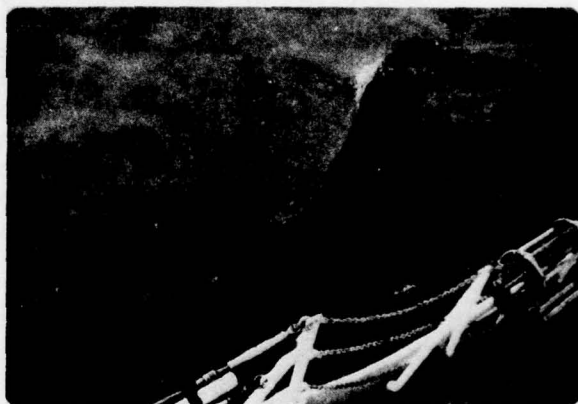
FIG. 27. Zone of Turbulence (Transect 3, 12/8/77)

Primary and secondary vessel-induced waves were well developed and consistent this run. This was especially evident to the starboard side of the cutter where the divergent bow waves rose rapidly before being cancelled by the oncoming swell. Ship generated waves to the sheltered portside were smaller and more regular. During initial formation the divergent (secondary) bow waves to the starboard pushed surface oil away from the hull. There also was a great deal of whitewater on the breaking wave crests which caused considerable mixing of entrained surface oil into the water column. Surprisingly, large patches of oil (i.e., up to three feet wide) were observed surfing down the backside of these bow waves between areas of whitewater (Figure 26). This oil then rode on the surface and along the side of the hull toward the stern. Additional oil was sloshed back toward the cutter by the oncoming sea swell which overrode the bow waves and forced oil on the wave crests into the ship's boundary layer area. As a result, oil covered much of the sea surface adjacent to the cutter (from amidships to the stern). The only exceptions to this pattern were areas of turbulence created at the interface between the breaking bow waves and the oncoming swell (Figure 27).
